**Flood Control Project Maintenance
Levee Inspections**

Fall 2014 Levee Maintenance Deficiency Summary Report

Sacramento River Basin

**Flood Control Project Maintenance
Levee Inspections
Unit Cover Sheet
Fall 2014 Levee Inspection Results
Yolo County Service Area 6**

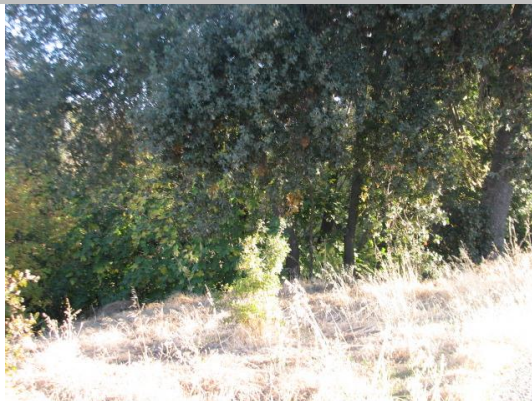
Photo 1 of 3 : FA_2014_NA0022_350_6_20141014_00008.jpg

Tall vegetation, trees and brush block visibility. Fall 2013

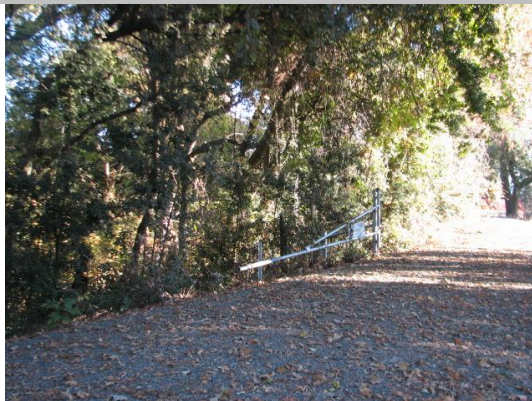
Photo 2 of 3 : FA_2014_NA0022_350_6_20141014_00009.jpg

Trees and brush block visibility. Fall 2013

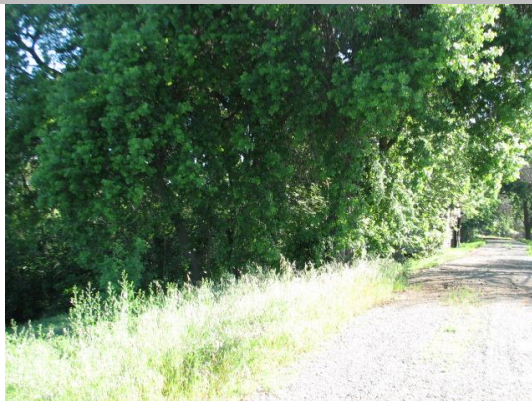
Photo 3 of 3 : FA_2014_NA0022_350_6_20141014_00010.jpg

Tall vegetation and trees block visibility. Spring 2014

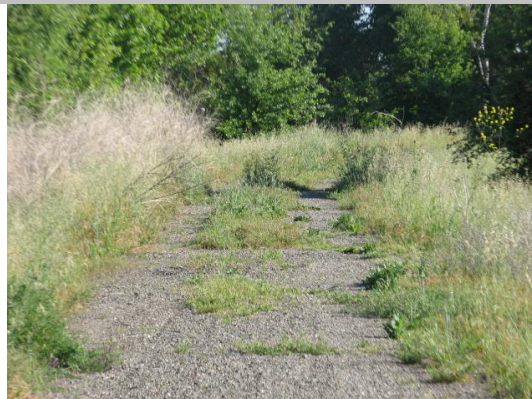
Photo 1 of 1 : FA_2014_NA0022_350_13_20141014_00017.jpg

The vegetation needs to be controlled on the crown. Spring 2014

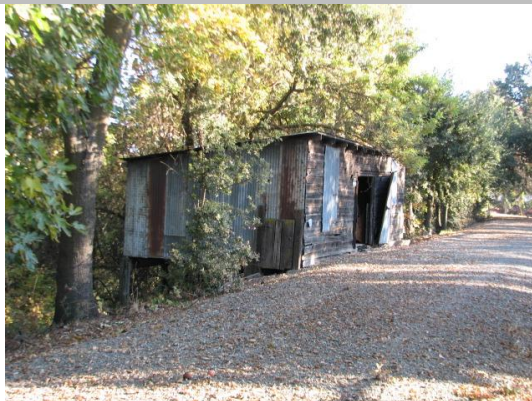
Photo 1 of 1 : FA_2014_NA0022_350_29_20141014_00036.jpg

The old barn is on the waterside of the levee. Fall 2013

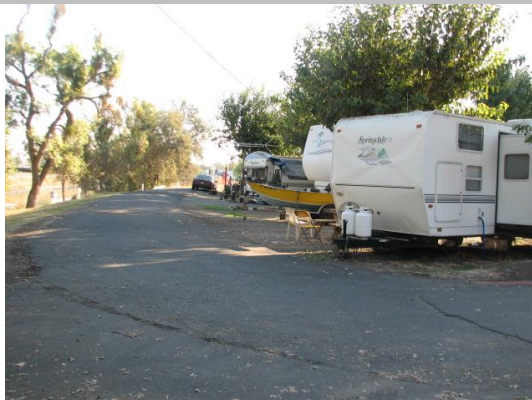
Photo 1 of 2 : FA_2014_NA0022_350_28_20141014_00034.jpg

The RV park is encroached into the levee crown. Fall 2013

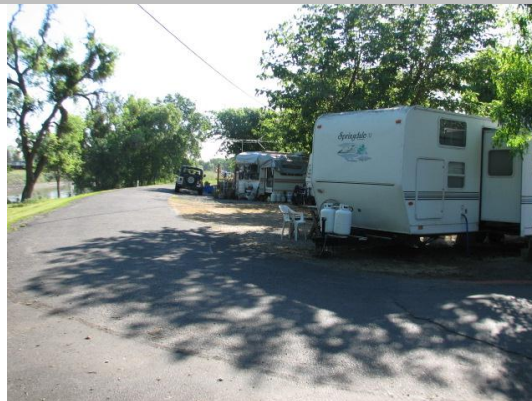
Photo 2 of 2 : FA_2014_NA0022_350_28_20141014_00035.jpg

Trailers on the crown of the levee. Spring 2014

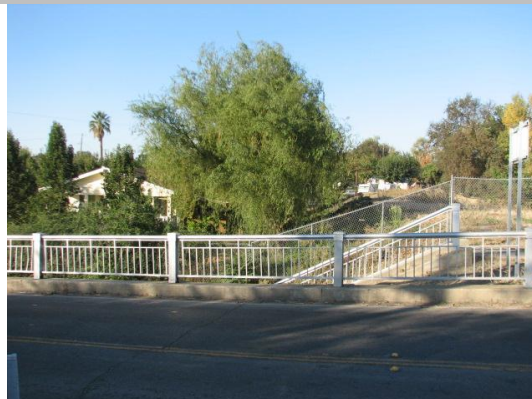
Photo 1 of 1 : FA_2014_NA0022_350_27_20141014_00033.jpg

Landscaping is encroach into the levee easement. Fall 2013

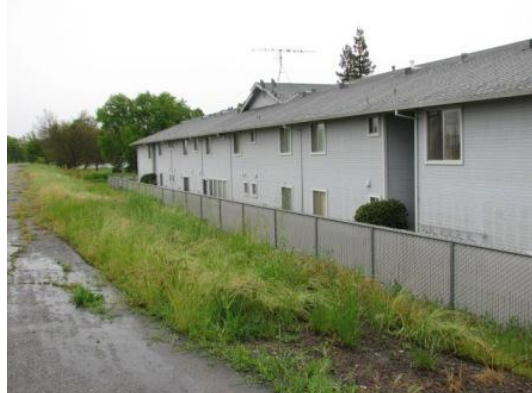
Photo 1 of 1 : FA_2014_NA0022_350_26_20141014_00032.jpg

The apartments and fence along the toe of the levee. Fall 2013

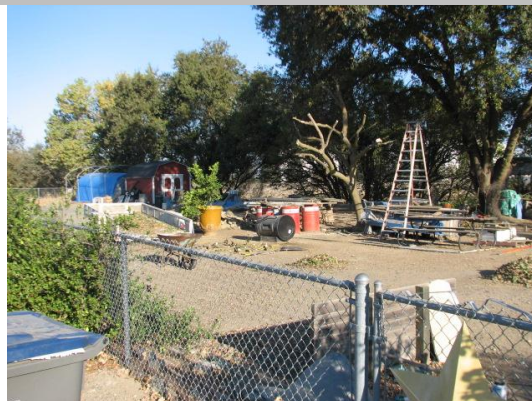
Photo 1 of 1 : FA_2014_NA0022_350_395_20141014_00060.jpg

LM Start	0.50	Rating **	M	Issue No.	395
LM End	0.55	Issue Type +	En	Location *	WS
Category	Earthen Levee			GPS Latitude/Longitude	
				Start	End
Item	Encroachments			38.802120 °	38.801882 °
				-121.716867 °	-121.716165 °
DWR ID	DWR_NA0022_01_f_2013_395				
Action/Comments					
Material

Material blocking visibility on the waterside of the levee. Fall 2013

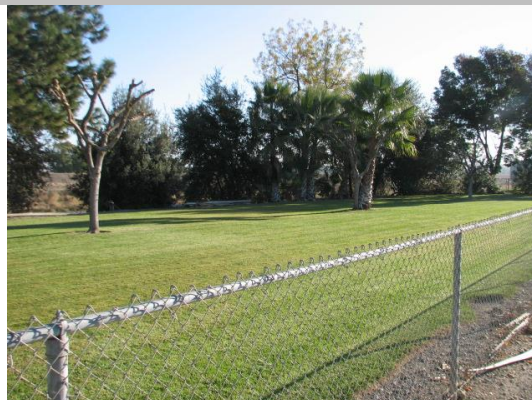
Photo 1 of 1 : FA_2014_NA0022_350_24_20141014_00030.jpg

The lawn area is on the levee waterside and crown. Fall 2013

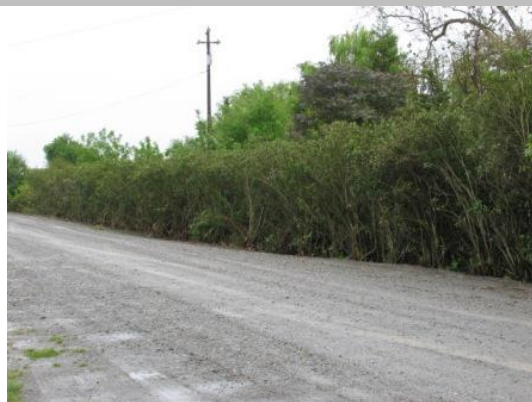
Photo 1 of 1 : FA_2014_NA0022_350_22_20141014_00028.jpg

Oleanders along the shoulder.

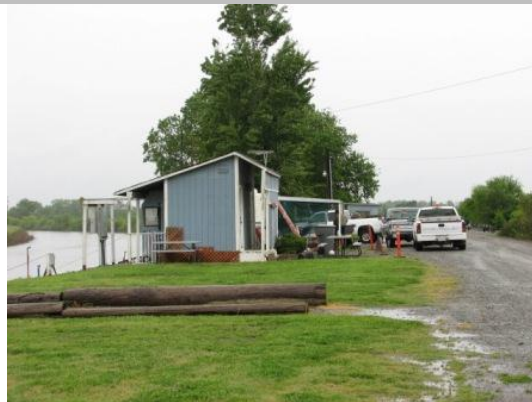
Photo 1 of 1 : FA_2014_NA0022_350_23_20141014_00029.jpg

LM Start	0.57	Rating **	A/W	Issue No.	23
LM End	0.65	Issue Type +	En	Location *	WS
Category	Earthen Levee			GPS Latitude/Longitude	
				Start	End
Item	Encroachments			38.801965 °	38.801468 °
				-121.715705 °	-121.714348 °
DWR ID	DWR_NA0022_01_s _ 2012_23				
Action/Comments					
Building					
Inspector Comments: Yolo Sutter Yacht Club

The Yacht club is on the crown. Fall 2013

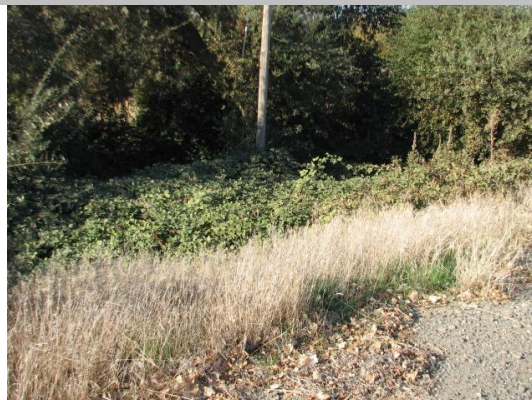
Photo 1 of 1 : FA_2014_NA0022_350_2_20141014_00002.jpg

The berries block visibility of the levee slope. Fall 2013

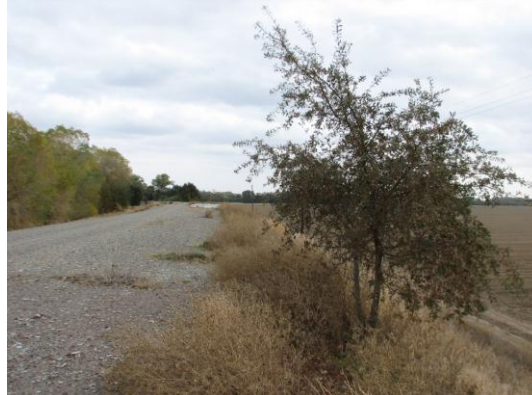
Photo 1 of 2 : FA_2014_NA0022_350_71_20141114_00062.jpg

Levee mile 0.75, vegetation on the land side slope. Fall 2014.

LM Start	0.75	Rating **	M	Issue No.	70
LM End	2.48	Issue Type +	Ma	Location *	LS
Category	Earthen Levee			GPS Latitude/Longitude	
				Start	End
Item	Vegetation			38.800866 °	38.788751 °
				-121.712803 °	-121.694286 °
DWR ID	DWR_NA0022_01_f_2014_70				
Action/Comments					
Control annual grass and weeds on the levee slopes and easements.

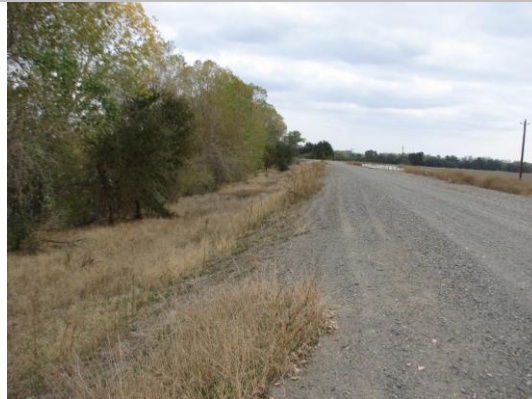
Photo 2 of 2 : FA_2014_NA0022_350_71_20141114_00063.jpg

Levee mile 0.75, vegetation on the water side slope. Fall 2014.

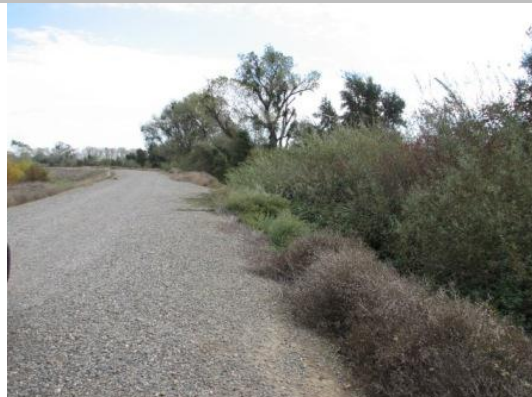
Photo 1 of 1 : FA_2014_NA0022_350_21_20141014_00027.jpg

The vegetation completely blocks the view of the levee slope. Fall 2011

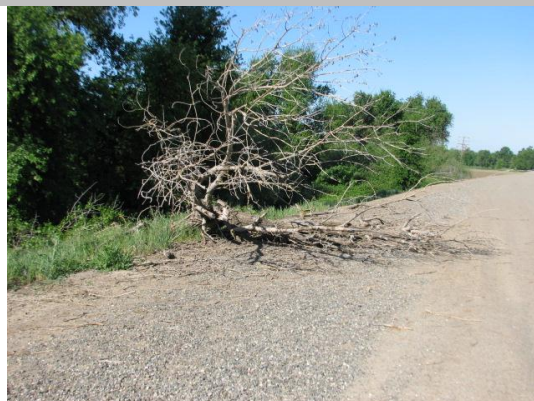
Photo 1 of 1 : FA_2014_NA0022_350_17_20141014_00022.jpg

A tree has fallen on the crown and blocks visibility. Spring 2014

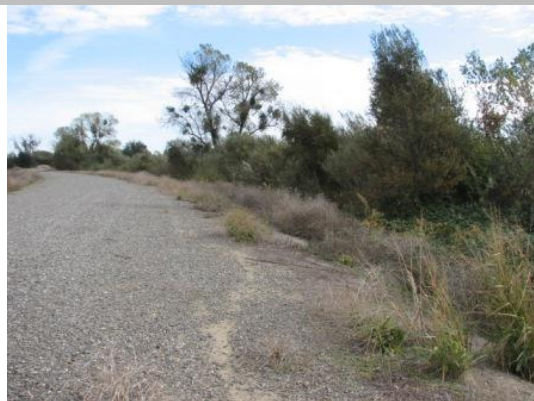
Photo 1 of 1 : FA_2014_NA0022_350_20_20141014_00026.jpg

LM Start	1.18	Rating **	M	Issue No.	20
LM End	1.34	Issue Type +	Ma	Location *	LS
Category	Earthen Levee			GPS Latitude/Longitude	
				Start	End
Item	Vegetation			38.800778 °	38.802058 °
				-121.705135 °	-121.702633 °
DWR ID	DWR_NA0022_01_s_2012_20				
Action/Comments					
Remove the wild growth other than native grasses from the levee slopes.

The vegetation blocks the view of the levee slope. Fall 2011

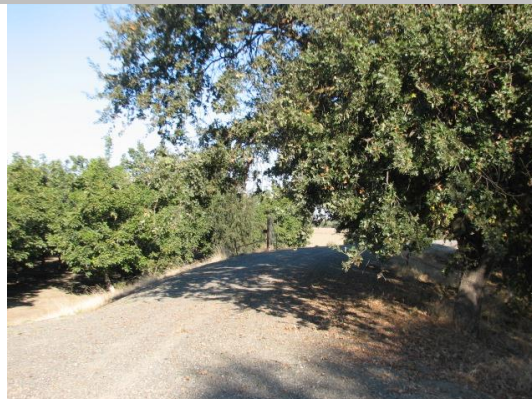
Photo 1 of 1 : FA_2014_NA0022_350_9_20141014_00013.jpg

Trees need to be trimmed up to 12 feet above the crown. Fall 2013

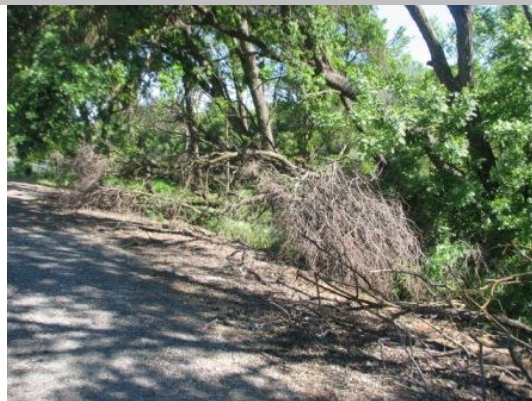
Photo 1 of 3 : FA_2014_NA0022_350_44_20141014_00051.jpg

LM Start	1.98	Rating **	M	Issue No.	44
LM End	1.98	Issue Type +	En	Location *	WS
Category	Earthen Levee			GPS Latitude/Longitude	
				Start	End
Item	Encroachments			38.795492 °	38.795492 °
				-121.695963 °	-121.695963 °
DWR ID	DWR_NA0022_01_s_2013_44				
Action/Comments					
Prunings

Branches and small trees have fallen on the levee slope. Spring 2013

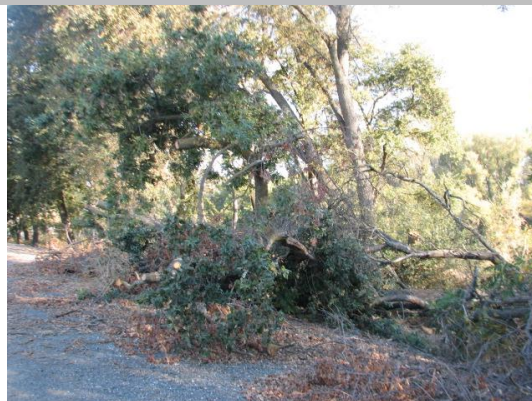
Photo 2 of 3 : FA_2014_NA0022_350_44_20141014_00052.jpg

A tree has fallen on the waterside levee slope and shoulder. Fall 2013

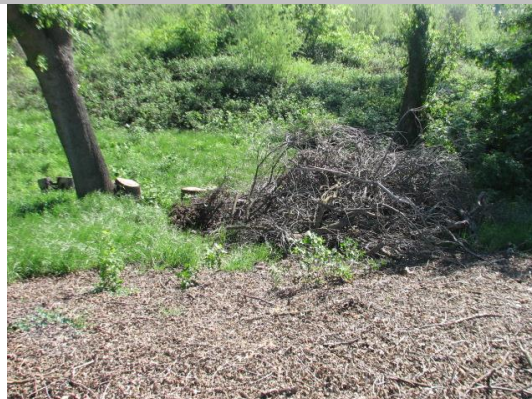
Photo 3 of 3 : FA_2014_NA0022_350_44_20141014_00053.jpg

The tree has been cut up but there is a brush pile left. Spring 2014

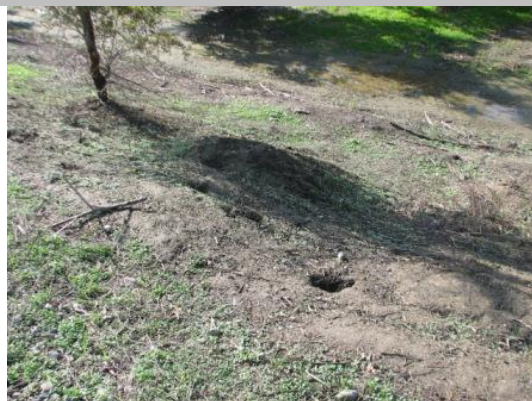
Photo 1 of 1 : FA_2014_NA0022_350_7_20141014_00011.jpg

Many rodent hole in this location on the slope. Fall 2012

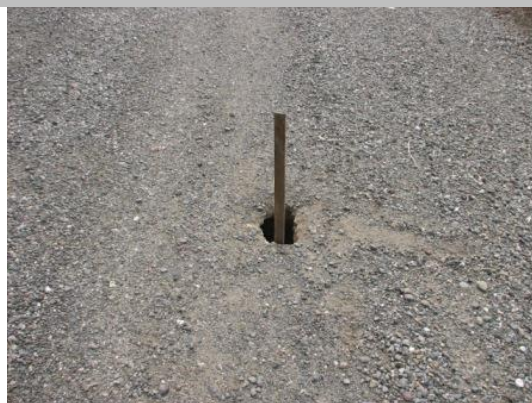
Photo 1 of 1 : FA_2014_NA0022_350_85_20141014_00057.jpg

LM Start	2.07	Rating **	M	Issue No.	85
LM End	2.07	Issue Type +	Ma	Location *	CR
Category	Earthen Levee			GPS Latitude/Longitude	
				Start	End
Item	Animal Control			38.794391 °	38.794391 °
				-121.695684 °	-121.695684 °
DWR ID	DWR_NA0022_01_s_2012_85				
Action/Comments					
No rodents visible, but rodent burrows visible; need to backfill and compact or grout burrows.

A rodent hole in the crown of the levee. Fall 2011

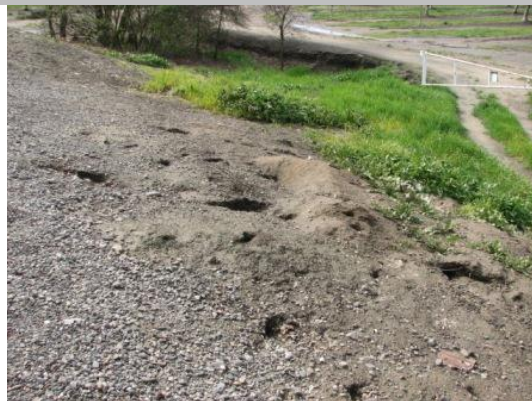
Photo 1 of 1 : FA_2014_NA0022_350_8_20141014_00012.jpg

There are multiple rodent holes but no visible rodents. Need to backfill and compact.

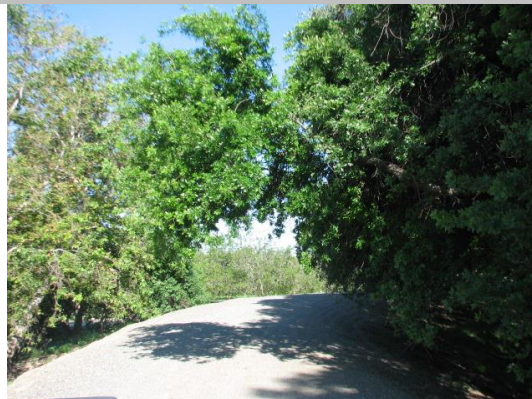
Photo 1 of 1 : FA_2014_NA0022_350_25_20141014_00031.jpg

Trees need to be trimmed up to at least 12 feet above the crown. Spring 2014

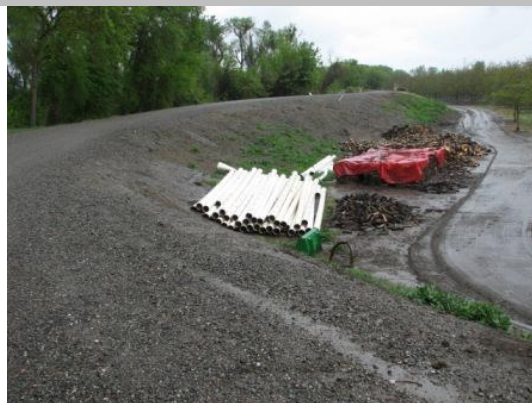
Photo 1 of 1 : FA_2014_NA0022_350_40_20141014_00047.jpg

LM Start	2.22	Rating **	M	Issue No.	40
LM End	2.22	Issue Type +	Ma	Location *	LS
Category	Earthen Levee			GPS Latitude/Longitude	
				Start	End
Item	Encroachments			38.792499 °	38.792499 °
				-121.695508 °	-121.695508 °
DWR ID	DWR_NA0022_01_s_2012_40				
Action/Comments					
Pipe

Pipe along toe.

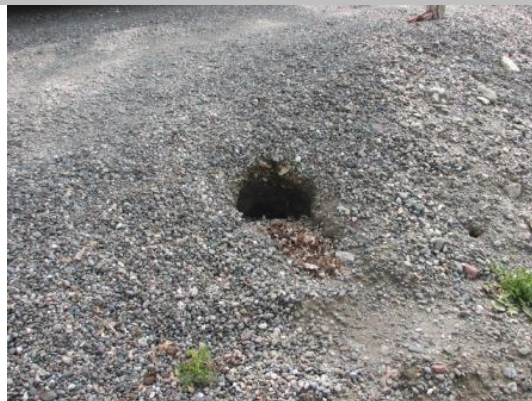
Photo 1 of 1 : FA_2014_NA0022_350_35_20141014_00040.jpg

LM Start	2.22	Rating **	M	Issue No.	35
LM End	2.22	Issue Type +	Ma	Location *	LS
Category	Earthen Levee			GPS Latitude/Longitude	
				Start	End
Item	Animal Control			38.792428 °	38.792428 °
				-121.695495 °	-121.695495 °
DWR ID	DWR_NA0022_01_s_2012_35				
Action/Comments					
No rodents visible, but rodent burrows visible; need to backfill and compact or grout burrows.

A rodent hole needs to be backfilled and compacted.

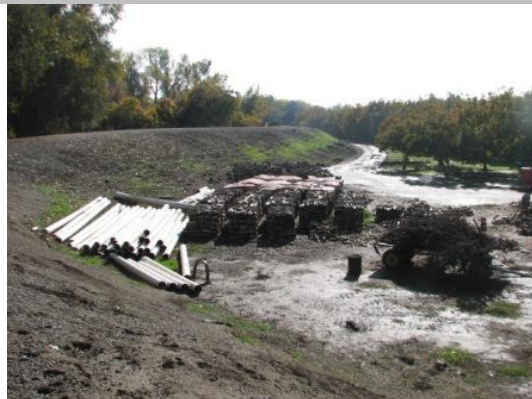
Photo 1 of 2 : FA_2014_NA0022_350_39_20141014_00045.jpg

The firewood pile is continuing to grow along the toe of the levee. Fall 2012

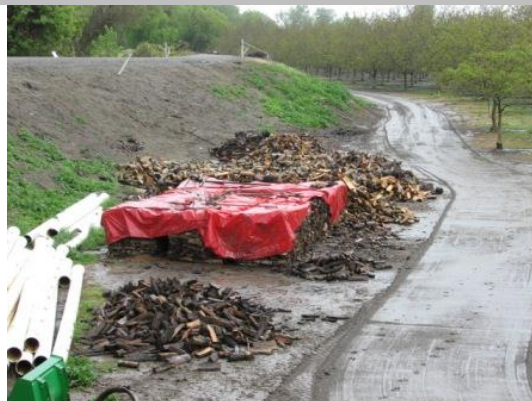
Photo 2 of 2 : FA_2014_NA0022_350_39_20141014_00046.jpg

Firewood stacked up.

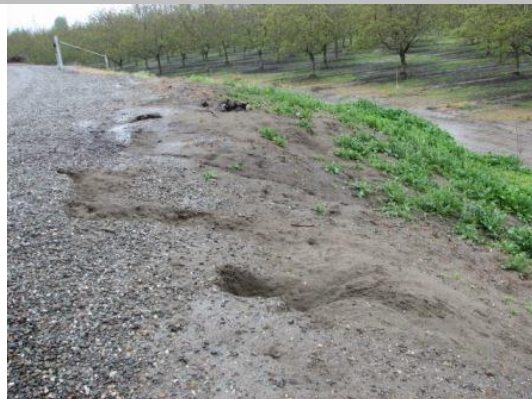
Photo 1 of 1 : FA_2014_NA0022_350_41_20141014_00048.jpg

LM Start	2.25	Rating **	M	Issue No.	41
LM End	2.25	Issue Type +	Ma	Location *	LS
Category	Earthen Levee			GPS Latitude/Longitude	
				Start	End
Item	Animal Control			38.792128 °	38.792128 °
				-121.695400 °	-121.695400 °
DWR ID	DWR_NA0022_01_s_2012_41				
Action/Comments					
No rodents visible, but rodent burrows visible; need to backfill and compact or grout burrows.

Rodents

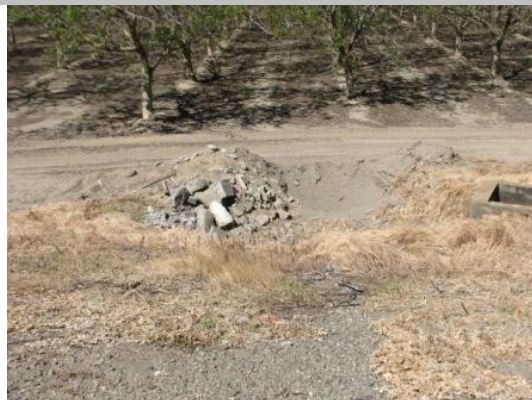
Photo 1 of 1 : FA_2014_NA0022_350_45_20141014_00054.jpg

Concrete debris is at the toe of the levee. Spring 2013

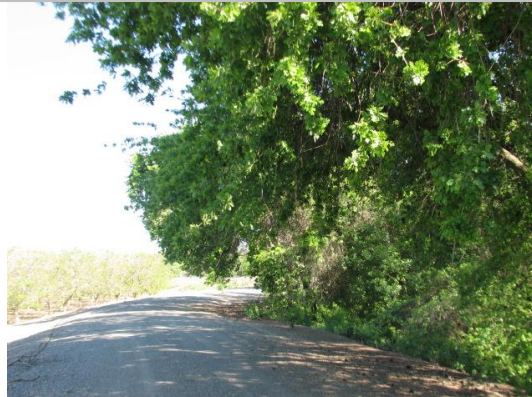
Photo 1 of 1 : FA_2014_NA0022_350_32_20141014_00039.jpg

Trees need to be trimmed up to at least 12 feet above the crown. Spring 2014

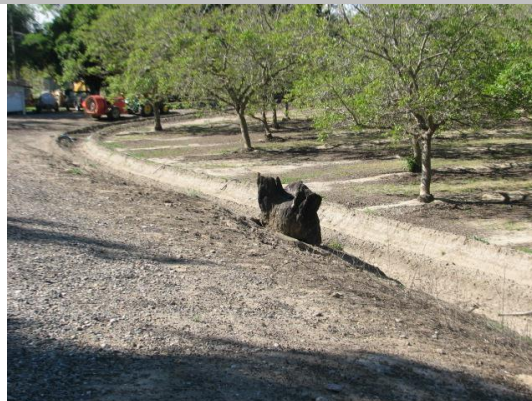
Photo 1 of 1 : FA_2014_NA0022_350_37_20141014_00044.jpg

Tree stump decomposing and may pose a risk to the levee. Spring 2014

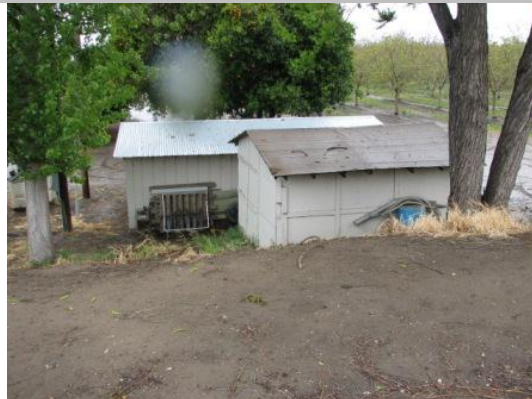
Photo 1 of 1 : FA_2014_NA0022_350_11_20141014_00014.jpg

Garage at toe.

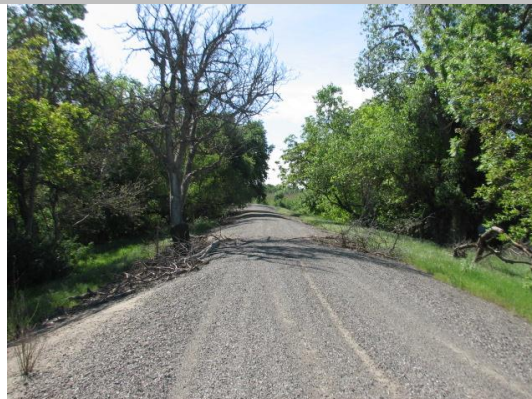
Photo 1 of 1 : FA_2014_NA0022_350_43_20141014_00050.jpg

A tree is dying and needs to be monitored may pose a threat to the levee. Spring 2014

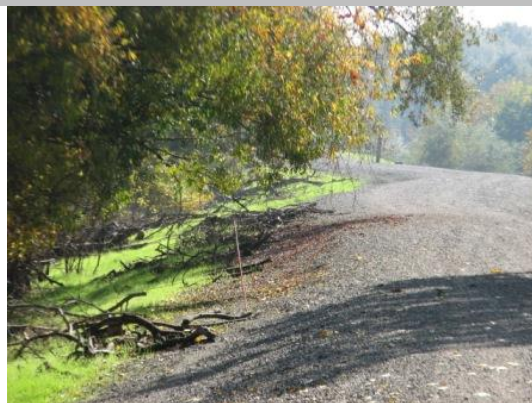
Photo 1 of 2 : FA_2014_NA0022_350_30_20141014_00037.jpg

Many piles are on the slope. Fall 2012.

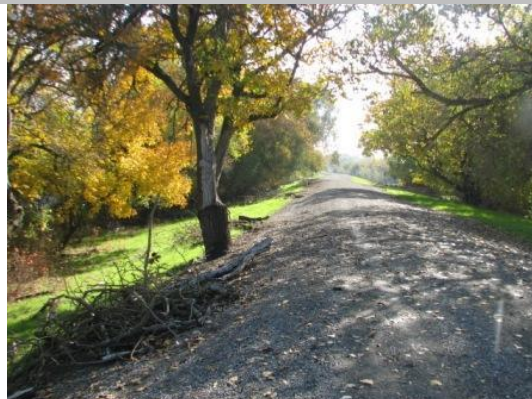
Photo 2 of 2 : FA_2014_NA0022_350_30_20141014_00038.jpg

Piles of prunings are on the waterside slope. Fall 2012

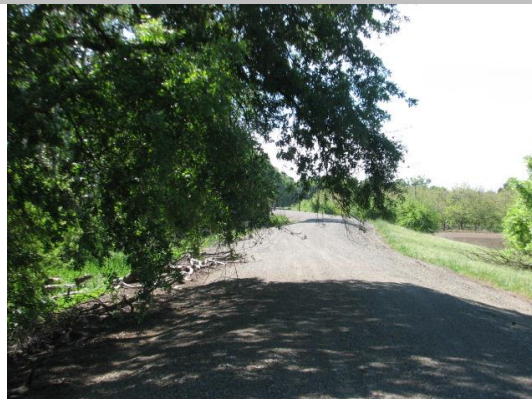
Photo 1 of 1 : FA_2014_NA0022_350_46_20141014_00055.jpg

Trees need to be trimmed up to at least 12 feet above the crown. Spring 2014

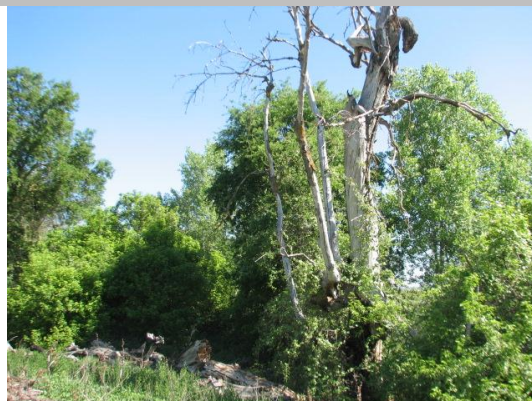
Photo 1 of 1 : FA_2014_NA0022_350_47_20141014_00056.jpg

Trees have fallen and others are dying need to be monitor. They may pose a threat to the levee. Spring 2014

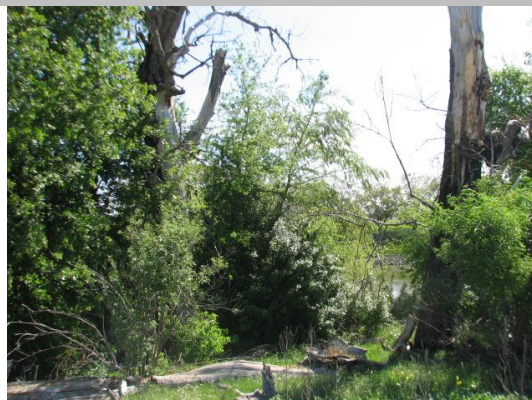
Photo 1 of 1 : FA_2014_NA0022_350_15_20141014_00019.jpg

Monitor dying trees they may pose to be a threat to the levee. Spring 2014

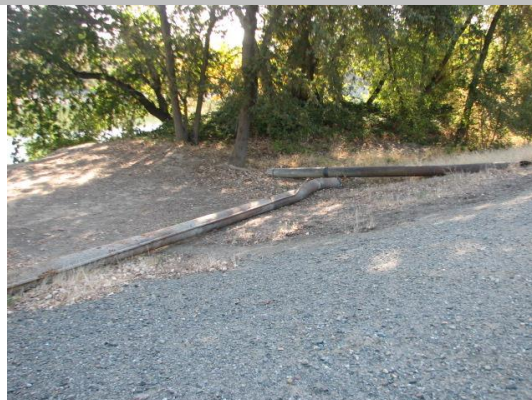
Photo 1 of 1 : FA_2014_NA0022_350_401_20141014_00061.jpg

Pipe has been laid on the waterside berm. Fall 2013

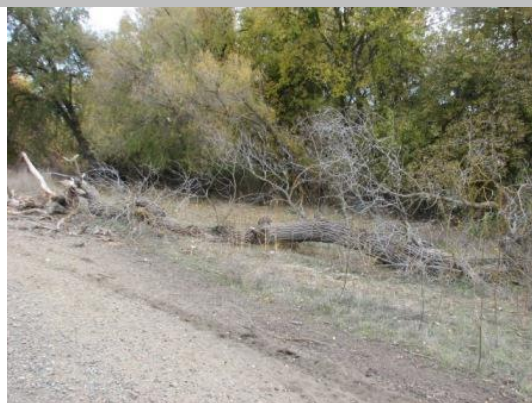
Photo 1 of 1 : FA_2014_NA0022_350_89_20141014_00059.jpg

Another tree has fallen on the waterside slope. Fall 2011

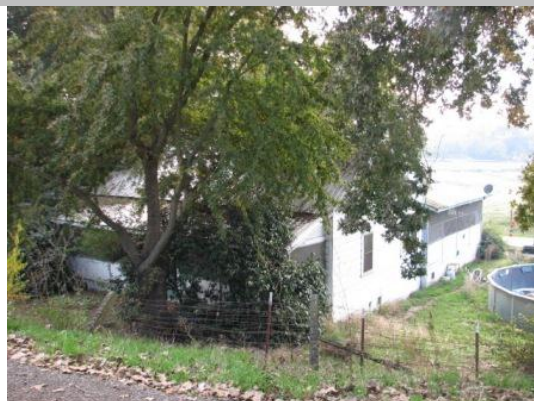
Photo 1 of 1 : FA_2014_NA0022_350_1_20141014_00001.jpg

The house and landscape are in the easement of the levee. Fall 2011
